## Construction Status Report

CP004028 – Beckman Institute (074) Courtyard Waterproofing

**Weekly Report:** 06/12/2026 (Friday)

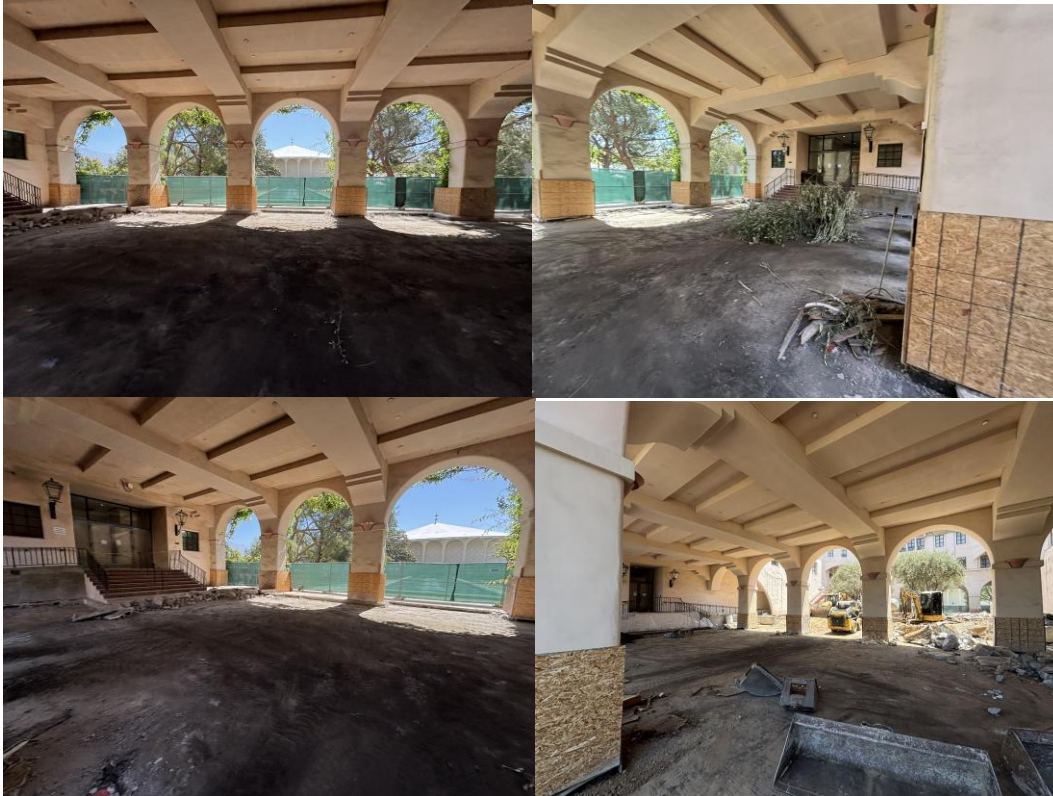
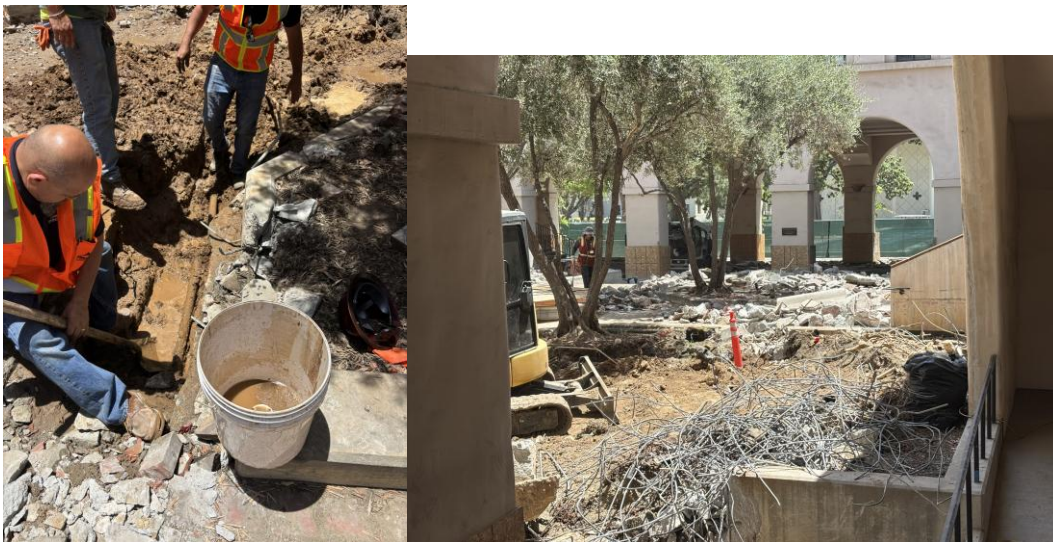
Irrigation – Industrial Cold Water Line

- Contractor encountered and damaged an approximately 1-1/2" buried copper irrigation line located beneath the courtyard slab.
- PD&C coordinated immediate response with CIT Plumbing Shop, Landscaping, Service Center, and Pinnacle.
- Water service isolated and affected line capped.
- Basement and Sub-Basement inspections completed.
- No active water intrusion or equipment impacts identified.

- Installation of exterior irrigation isolation valve
- Removal, cut and cap of courtyard irrigation infrastructure
- Utility vault relocation review underway
- Three vault configurations currently under evaluation with CIT Operations and Pinnacle
